## Review of Mark V Incident at JIVE on March 1, 2003.

March 23, 2003

This document reviews the events and findings related to the incident at the JIVE facility on Saturday, March 1, 2003.

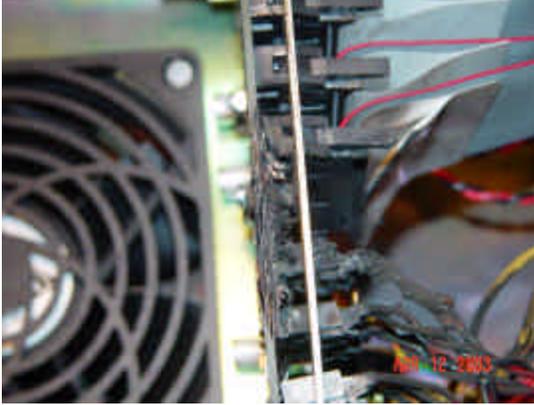
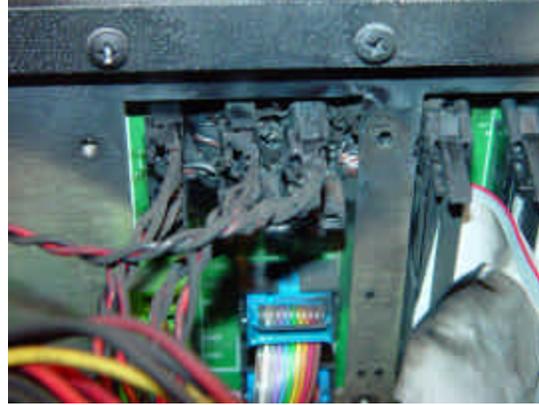
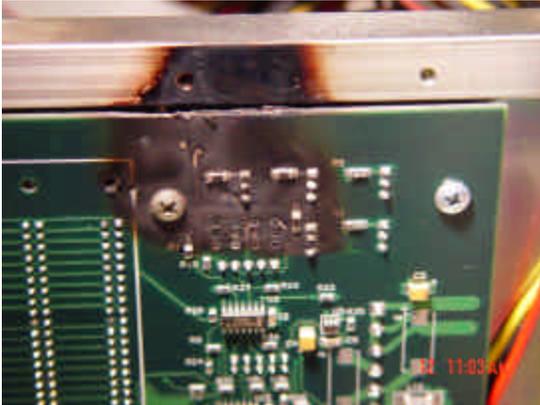
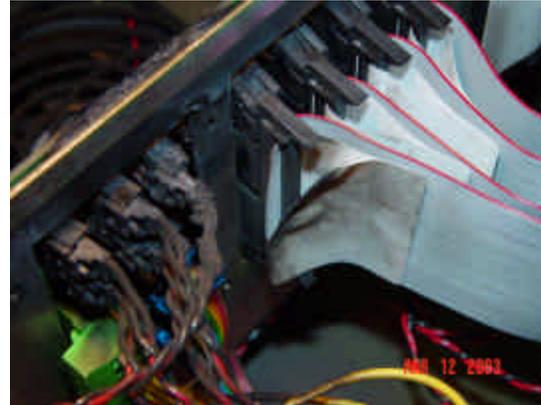
**Different views of damaged area of system before disassembly.**

The insulation on red wires from J14 and J15 appears to be melted together. Further testing indicates that they are shorted together, though they should read about 1 ohm due to the two 0.5 ohm resistors between those two points.

The area around J15 and the adjacent screw appeared to be the hottest area. ATA connector J5 shows heat damage on the side near the screw. Fan connector J15 is melted on all sides and adjacent fan connectors are melted on the sides facing J15. Connectors that are further away also show little evidence of extreme heat, though they are covered with "ash". The white pull tab on the ATA cable that was connected to J5 showed heat damage. The insulation on the wires connected to J15 melted together and to the J15 connector housing.

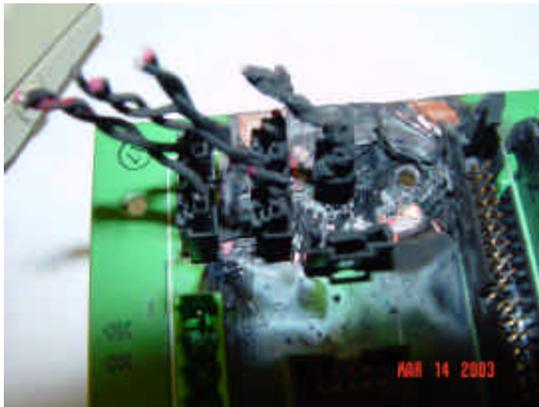
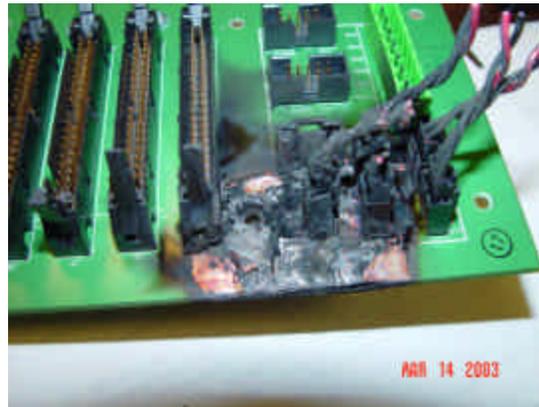
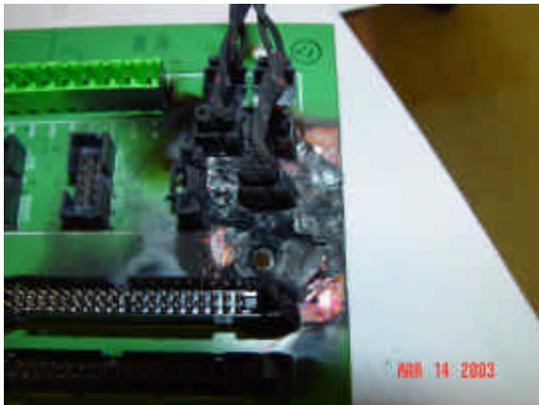
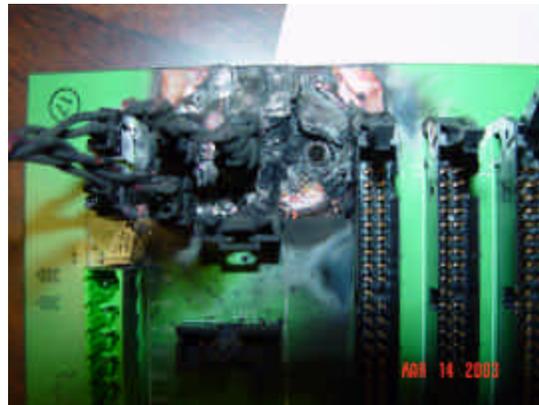
**Different views of back side of backplane after removal.**

J15 was noticeably hotter than the other fan connectors. All sides of it were melted. The solder that held the connector in place appears like it became very hot, along with solder on a couple other fan connectors. The sides of all the adjacent connectors facing J15 were also melted while sides of those other connectors facing away showed little signs of heat damage. The insulation on the wires connected to J15 was also severely melted, much more so than those on other fan connectors.

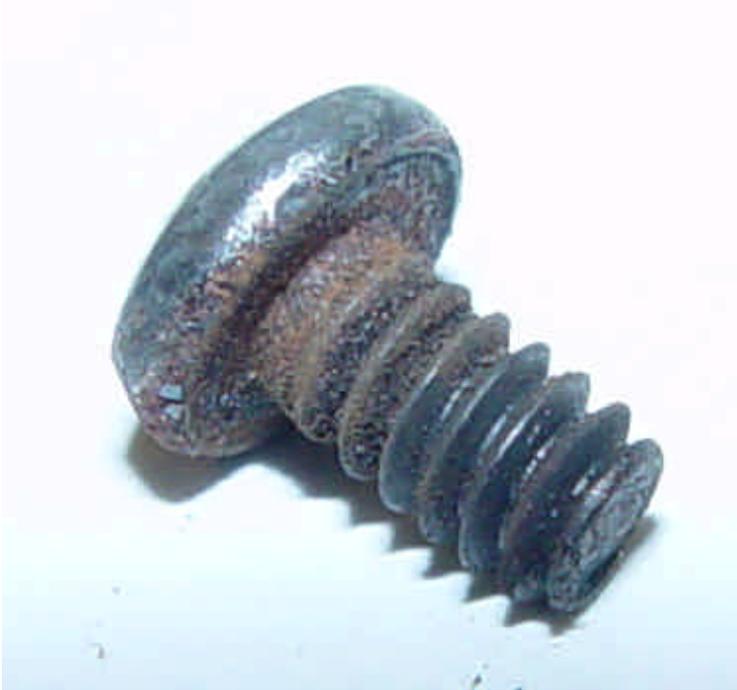
The screw on front side of motherboard to the left of J15 appears electrically isolated from GND, 5V, and 12V. All other screws easily show short to GND. Additional pressure on the screw makes intermittent connection down to 400 ohms.

The picture below is of the mounting screw near J15. Even with the screw removed, it is difficult to measure continuity from one end to the other without scraping down to the metal.

**The screw removed from the mounting hole near J15.**

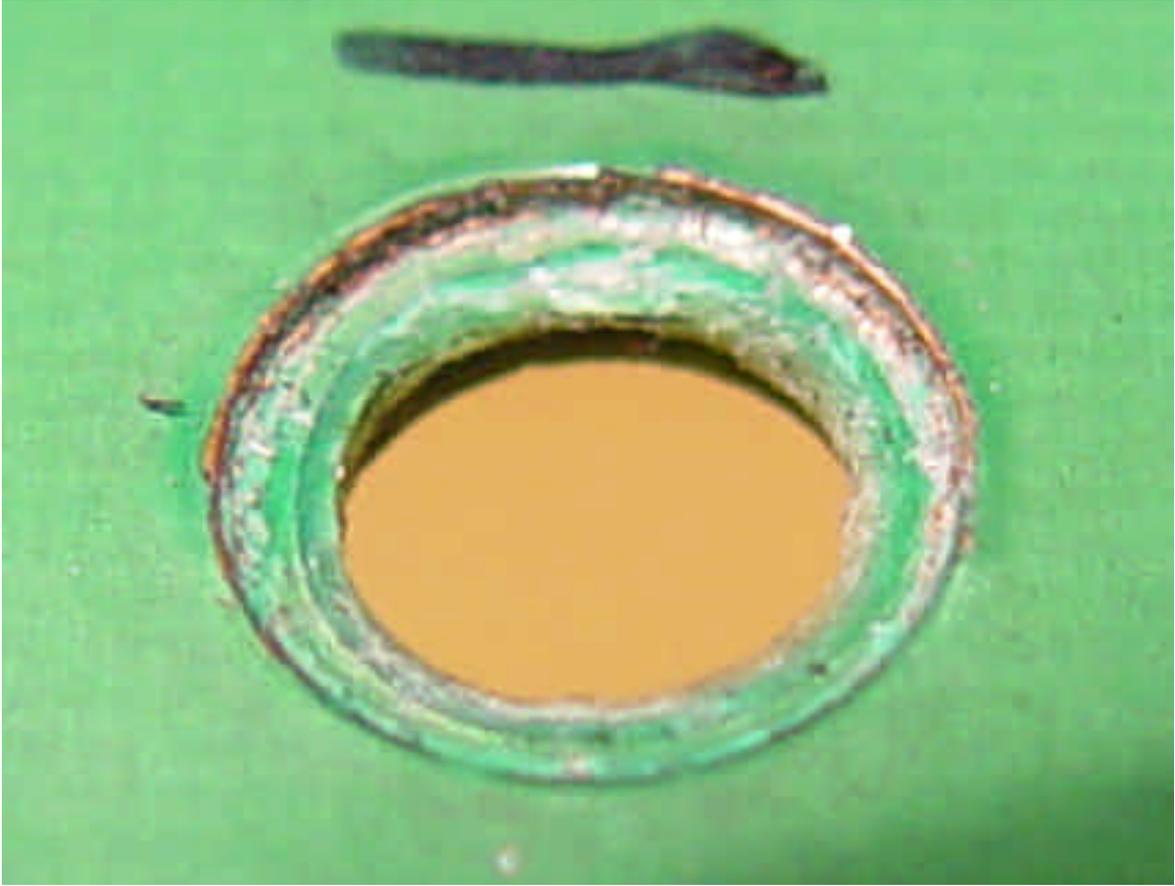
Hole number 1.

The pictures below show impressions left on the board around some of the other holes that were not involved in the burn damage. Some show deep impressions into the board made by the standoffs while others show that the impressions actually exposed copper from the GND and 5V planes. The last picture shows the impression left around the standoff in the burn area once the board was removed. Because this area is blistered, there is no positive way to determine how compressed it was before the damage.

As is the case with this backplane, other backplanes have also been removed and replaced since they left Conduant, if for no other reason, to add the FET hardware kit in the field. Any backplanes which may have been subjected to excessive tightening for any reason should be removed and inspected for damage on both sides of the board around the mounting holes.

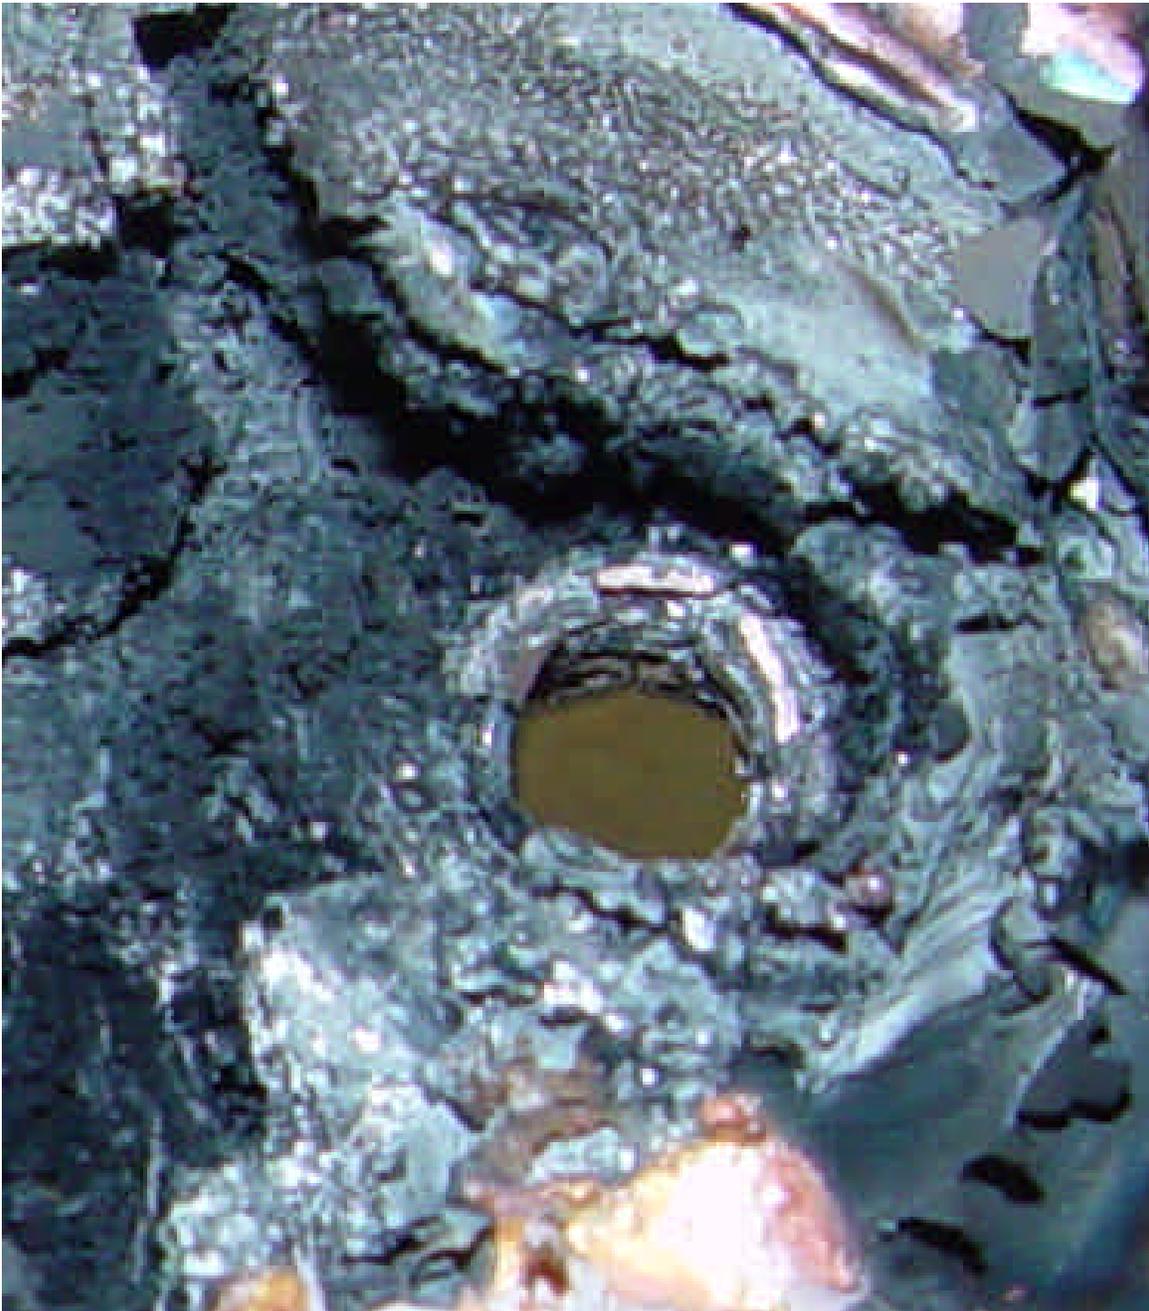
Hole number 6.

It is believed that the primary cause of the failure is severe over-tightening of the screw at hole six. The tightening sufficiently compressed and deformed the copper plane layers between the screw head and the associated standoff so as to create a resistive connection between the GND plane on layer 8 and the 5V plane on layer 6. The connection did not draw sufficient current to cause the power supply to shutdown, but it did draw enough current to generate significant heat. The screw in the hole shows considerable damage but it is not known if the screw was part of the conductive path.

The high current in the 5V portion of the split power plane caused that plane to significantly heat its border with the 12V portion of the plane. The damage caused by that heat resulted in a formation of another low resistance path between 12V and GND, perhaps under J15. While generating significant heat, neither path to GND drew sufficient current to trip the shutdown circuits in the power supply.

Conduant was unable to intentionally inflict the kind of compression around the mounting holes that was obvious on the returned board. As indicated earlier, it is known that the backplane was removed and replaced at least once since it left Conduant. It is believed that an assembly tool such as an impact driver may have been used at some time in a mounting process since the backplane left Conduant. Such a tool might deliver its force in repeatedly short bursts that might allow the screw to get tighter without sheering off.

Conduant will generate a technical bulletin for use by clients who perform TK200 assembly operations in the field. It will include a warning regarding excessive tightening of mounting hole screws. It will also include specific torque and liquid fastener requirements.

Conduant is reviewing updates to the backplane. One update being considered is to increase the clearance of copper around the mounting holes, thus making the backplane more tolerant of excessive torque.

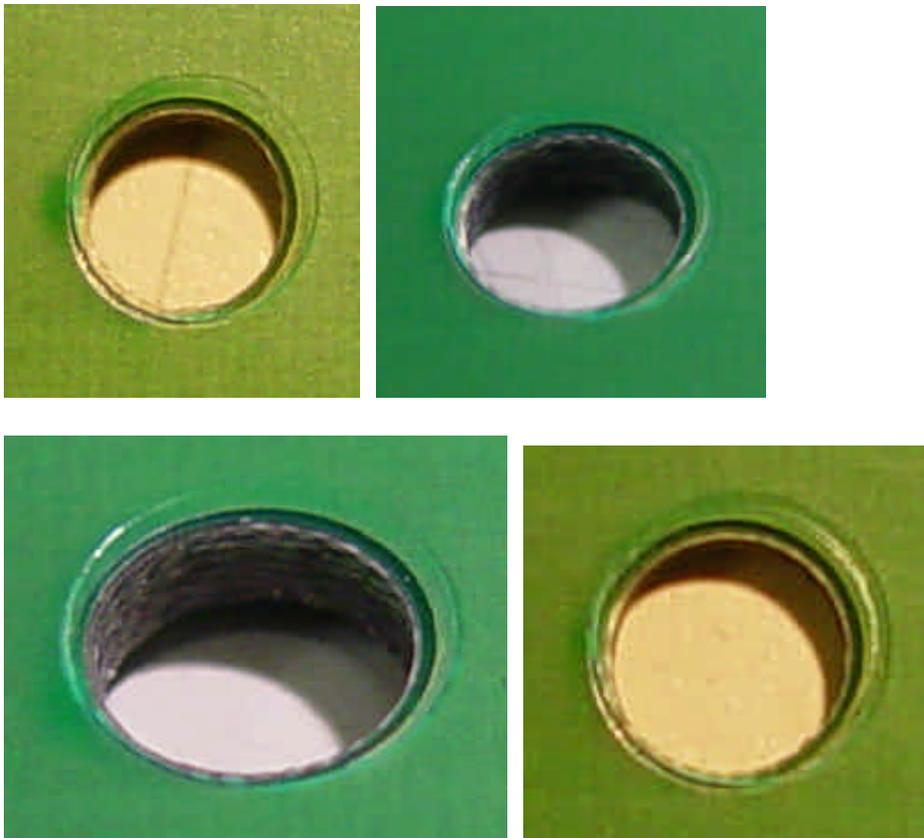
Adjusting the clutch setting to 3.5, 4.0, and 4.5 produced increasingly more noticeable indentations on the rear of the backplane. At "2 speed" and a clutch setting of 4.5, the manual represents this as an approximate torque of 17.5 inch-lbs. The following 4 pictures show the impressions on 4 different holes made with these settings.

**Impressions on 4 different mounting holes with Milwaukee driver settings at 166% of the Conduant manufacturing standards.**

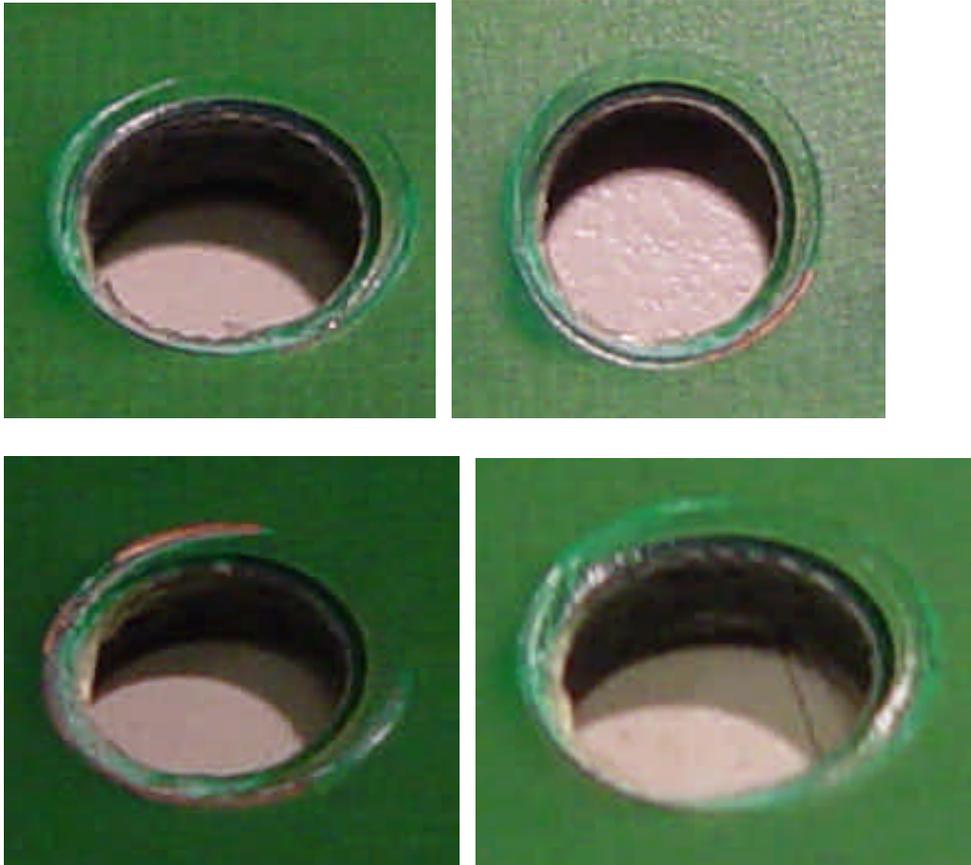
The clutch was then adjusted to its maximum value of 6. A "2 speed" and clutch setting of 6 corresponds to an approximate torque of 26 in-lbs. With these settings, the copper GND plane directly under some of the standoffs is now exposed and would explicitly connect backplane GND to the chassis GND through the underlying standoff. Impressions made with these settings are shown in the next four pictures.

**Impressions on 4 different mounting holes with Milwaukee driver settings at 248% of the Conduant manufacturing standards.**
