Status Report on the Tsukuba VLBI Station

– Damage to the Substructure of the Antenna and Its Repair –

Takahiro Wakasugi, Ryoji Kawabata

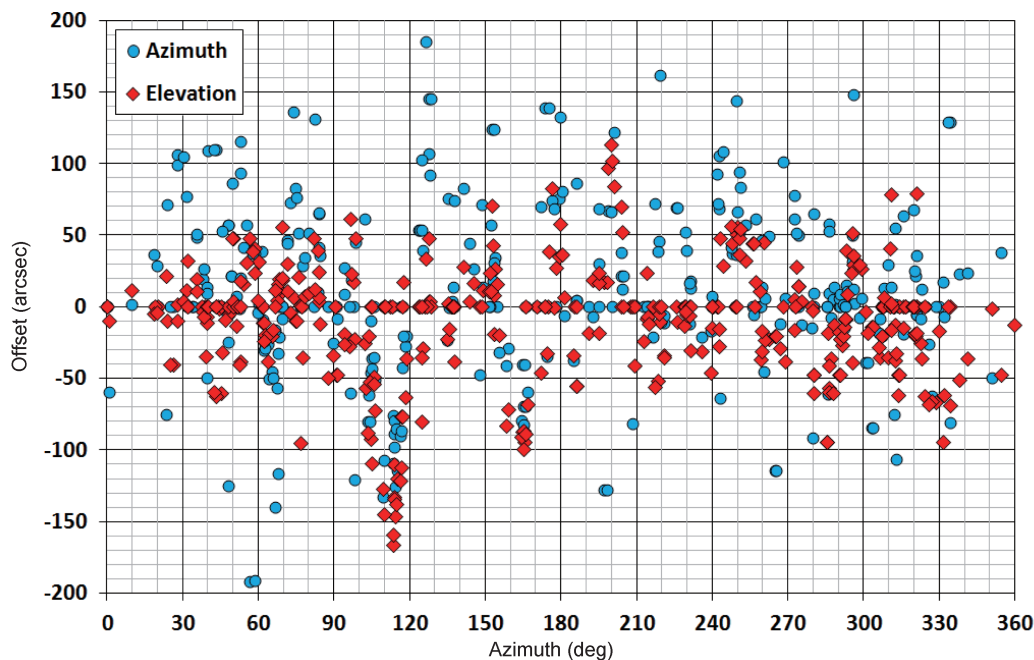
Figure 2 shows the result of the pointing offset in April. Large offsets occurred at specific azimuths in both the azimuth and the elevation plots. The maximum elevation offset was 170 arcseconds at the azimuth angle of 115 degrees, which was large enough to disturb observations because the beam half-value width of the Tsukuba antenna for X-band was about 250 arcseconds.

Fig. 2 The pointing offset of azimuth and elevation in April 2013 plotted as a function of the azimuth direction.

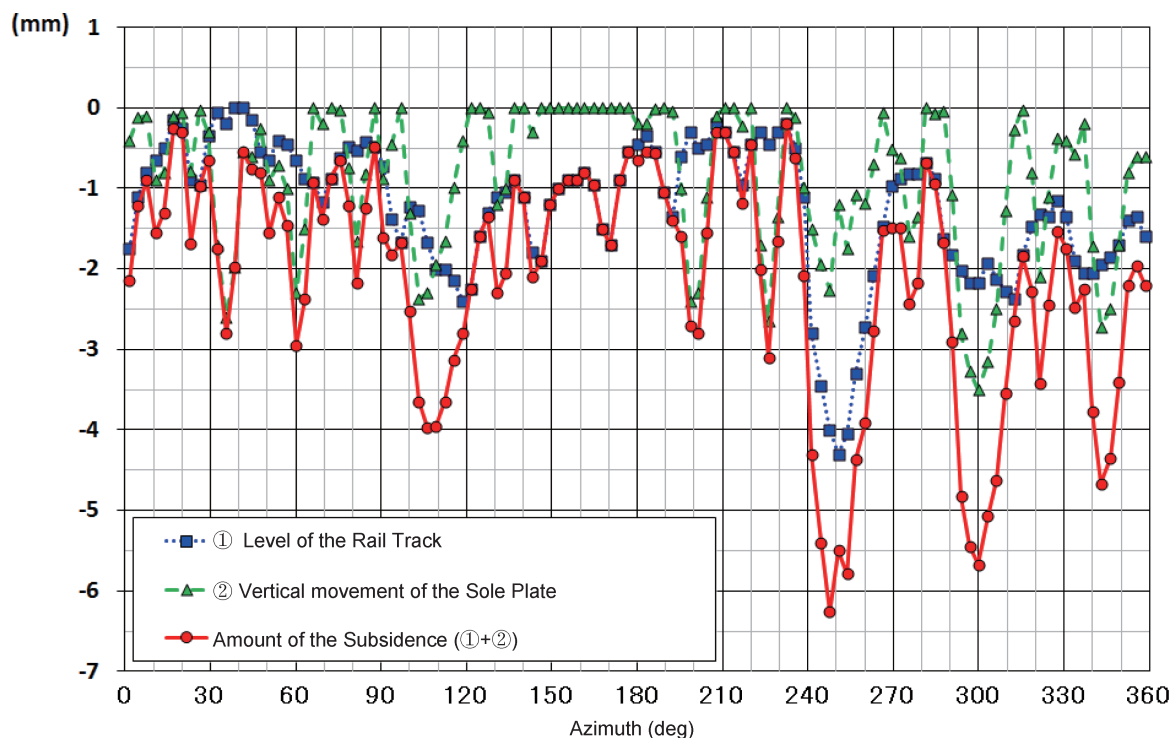
Figure 4 shows the results of the leveling and the vertical movement. It turned out from the leveling that almost all the rail tracks were distorted in a convex shape while only one rail track at the azimuth angle of 250 degrees was deformed concavely. The range of

the level reached to 4 mm. The second investigation revealed the vertical movements of almost all the sole plates at their boundaries. The maximum amount of the vertical movement was up to 3.5 mm. The estimated

Fig. 4 The results of the leveling, the vertical movements, and the estimated subsidence amounts of the antenna. The blue squares, the green triangles, and the red circles show the level of the rail tracks, the vertical movements of the sole plates, and the estimated subsidence of the antenna respectively.

subsidence amount of the antenna was also plotted in Figure 4. The maximum subsidence came to 6 mm.

In order to prevent the antenna from subsiding and to reduce the offset, we conducted two kinds of repairs. One repair was the lifting up of the concavely deformed rail track. The other repair was the filling up of the gaps under the sole plates with new firm grout. It was con-

ducted under high pressure in order to fill every corner of the gaps.

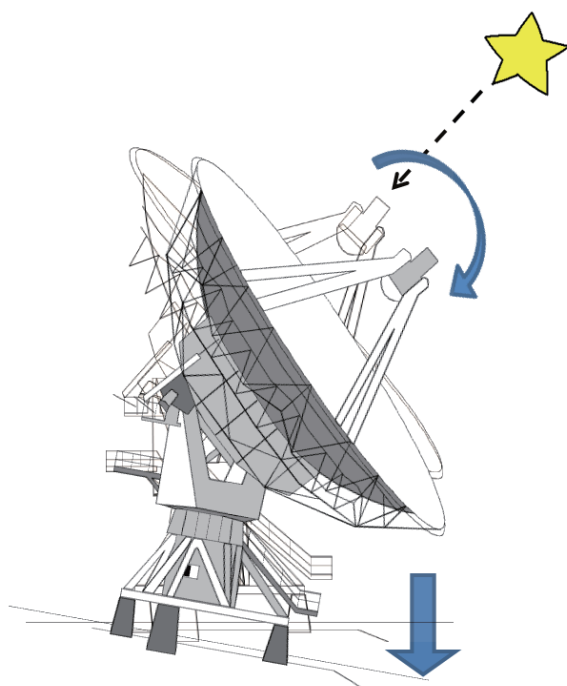
Assuming that the superstructure of the antenna is a rigid body, the antenna will miss the target when the wheels are located on subsidence spots (Figure 5). For example, we consider the case that one of the wheels is located on the maximum subsidence spot. In this case, both of the front wheels subside about 5 mm while both of the rear wheels scarcely subside (Figure 6). Five millimeters of the subsidence of the front wheels causes 52 arcseconds of the offset. The actually measured elevation pointing offset in such an arrangement of the wheels was 51 arcseconds (see Figure 2). That is, the subsidence of the antenna is able to cause the measured offset.

Fig. 5 Missing the target if some wheels subside.

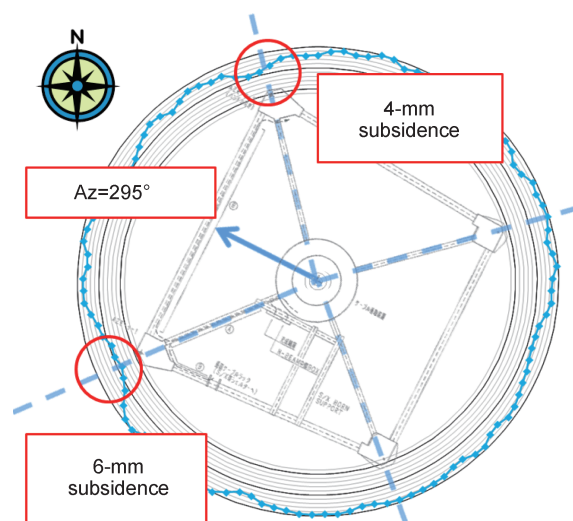
Fig. 6 The configuration of the antenna when one of the wheels is located on the maximum subsidence spot.

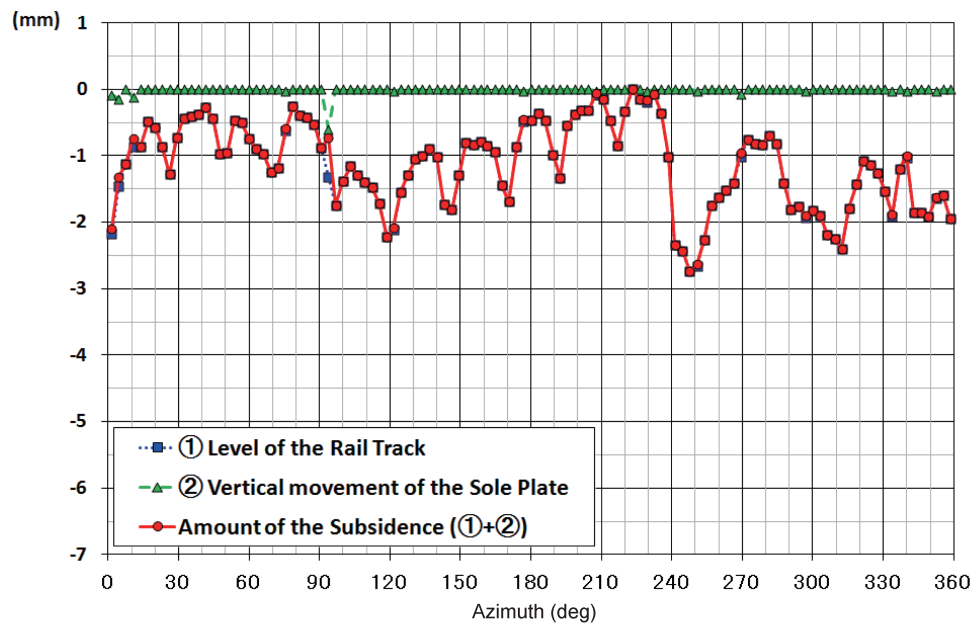
After the repair, we measured the level and the vertical movements again. As a result, the concavely deformed rail track was raised by 1.5 mm, and almost all the vertical movements of the sole plates no longer existed. Eventually, the range of the subsidence was reduced to 2.5 mm (Figure 7).

Fig. 7 The results of the investigations after the repair. The blue squares, the green triangles, and the red circles show the level of the rail tracks, and the vertical movements of the sole plates and the estimated subsidence, respectively.

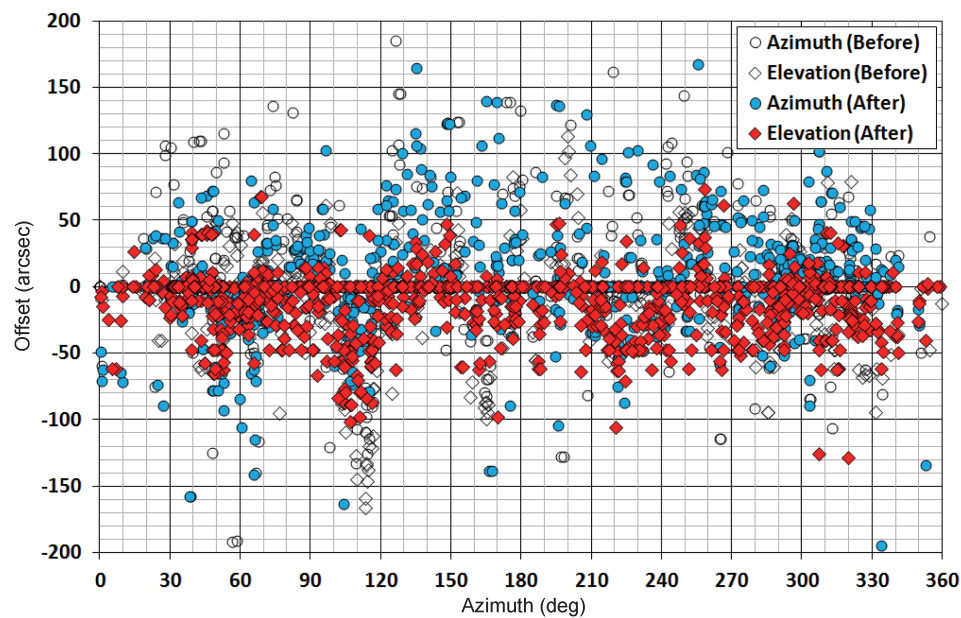
We checked the pointing accuracy of the antenna after those measurements. Although some of the offsets remained, most of the offsets were improved. The maximum offset was reduced to 100 arcseconds, which did not have harmful influence on observations (Figure 8). At last, we resumed observations from the end of November.

Fig. 8 The azimuth and elevation pointing offsets after the repair plotted as a function of the azimuth direction. The offsets before the repair are also plotted by open circles and rhombuses.
