## Review of Mark V Incident at JIVE on March 1, 2003.

March 23, 2003

This document reviews the events and findings related to the incident at the JIVE facility on Saturday, March 1, 2003.

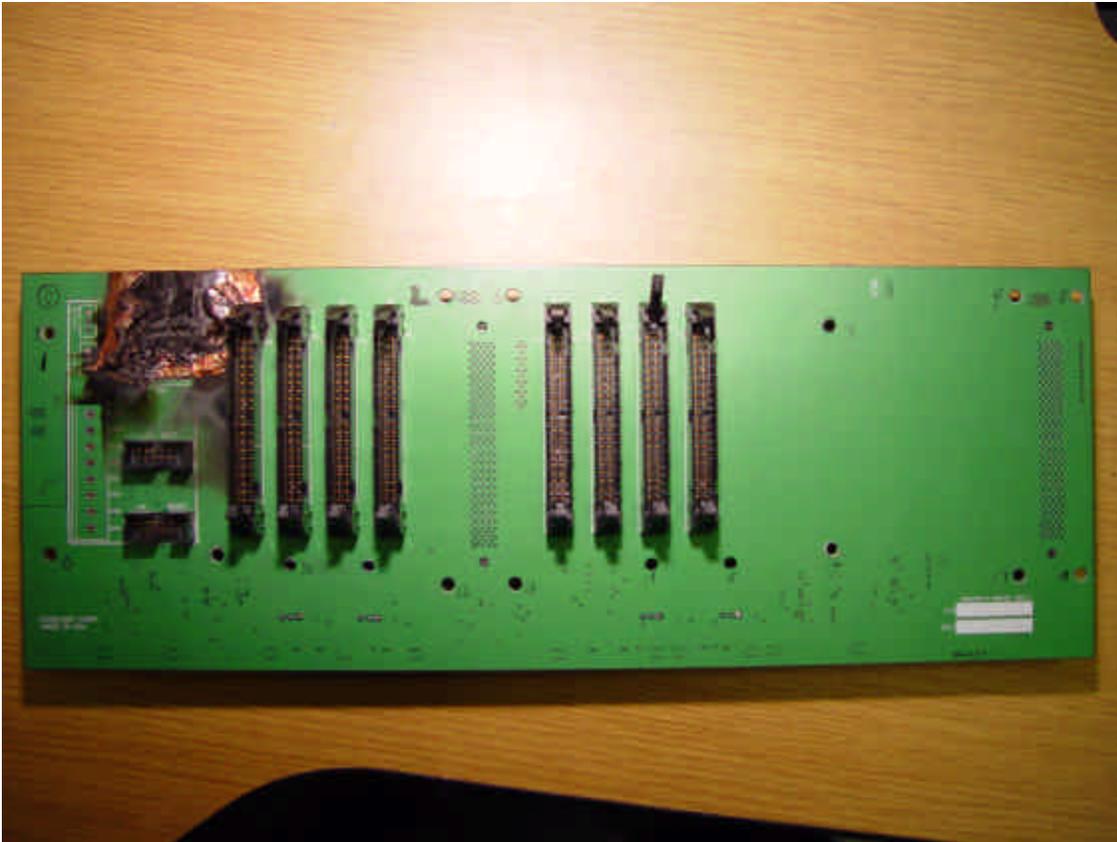
The pictures below show impressions left on the board around some of the other holes that were not involved in the burn damage. Some show deep impressions into the board made by the standoffs while others show that the impressions actually exposed copper from the GND and 5V planes. The last picture shows the impression left around the standoff in the burn area once the board was removed. Because this area is blistered, there is no positive way to determine how compressed it was before the damage.

Entire board with board numbers for reference.
