Status Report on the Tsukuba VLBI Station

– Damage to the Substructure of the Antenna and Its Repair –

Takahiro Wakasugi, Ryoji Kawabata

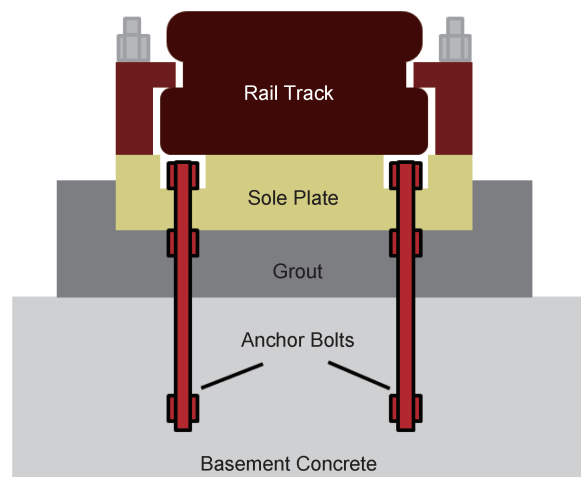
Fig. 3 A schematic cross section of the substructure of the antenna.

Figure 3 is the schematic cross section of the substructure of the antenna. The rail track is mounted on the sole plate, and the sole plate is locked to the basement concrete by some anchor bolts. The space between the rail track and the sole plate is filled with cementitious grout. Additionally, the rail track and the sole plate are divided into several pieces, and those boundaries are arranged alternately.

In order to know the damage in detail, we conducted two kinds of investigations. One was leveling on the rail tracks under a no load condition. The other was the measurement of the vertical movements of the sole plates to the grout when the wheel passed through. Adding these results, we can understand the subsidence amount of the antenna from the reference level.

In order to prevent the antenna from subsiding and to reduce the offset, we conducted two kinds of repairs. One repair was the lifting up of the concavely deformed rail track. The other repair was the filling up of the gaps under the sole plates with new firm grout. It was con-
